AudioCodes Boards Fail to Initialize

Issue Date: 2/15/06

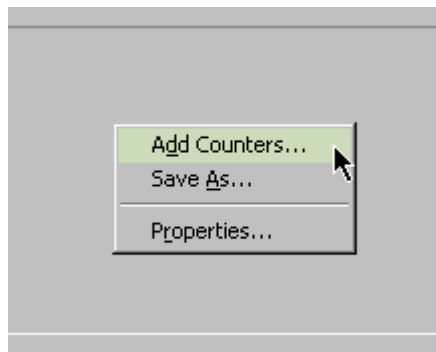
TABLE 3: ADD COUNTER

2. Next, add the "Free System Page Table Entries" counter from the "memory" object. Right click inside the performance field and select "Add Counter" from the menu. In the window that appears, choose "Memory" from the Performance object menu, and "Free System Page Table Entries" from the counter list. When finished, Click "Add".
